Re: Birch Spring Action Plan, Tech Directive 005, Bear Canyon Mine, ACT/015/025, Emery County, Utah

This letter is to summarize the progress of the work which has been accomplished on Steps 3 and 4 of the Action Plan which was approved by the Division per letter dated August 7, 1998.

Birch Spring
Faults and Fractures

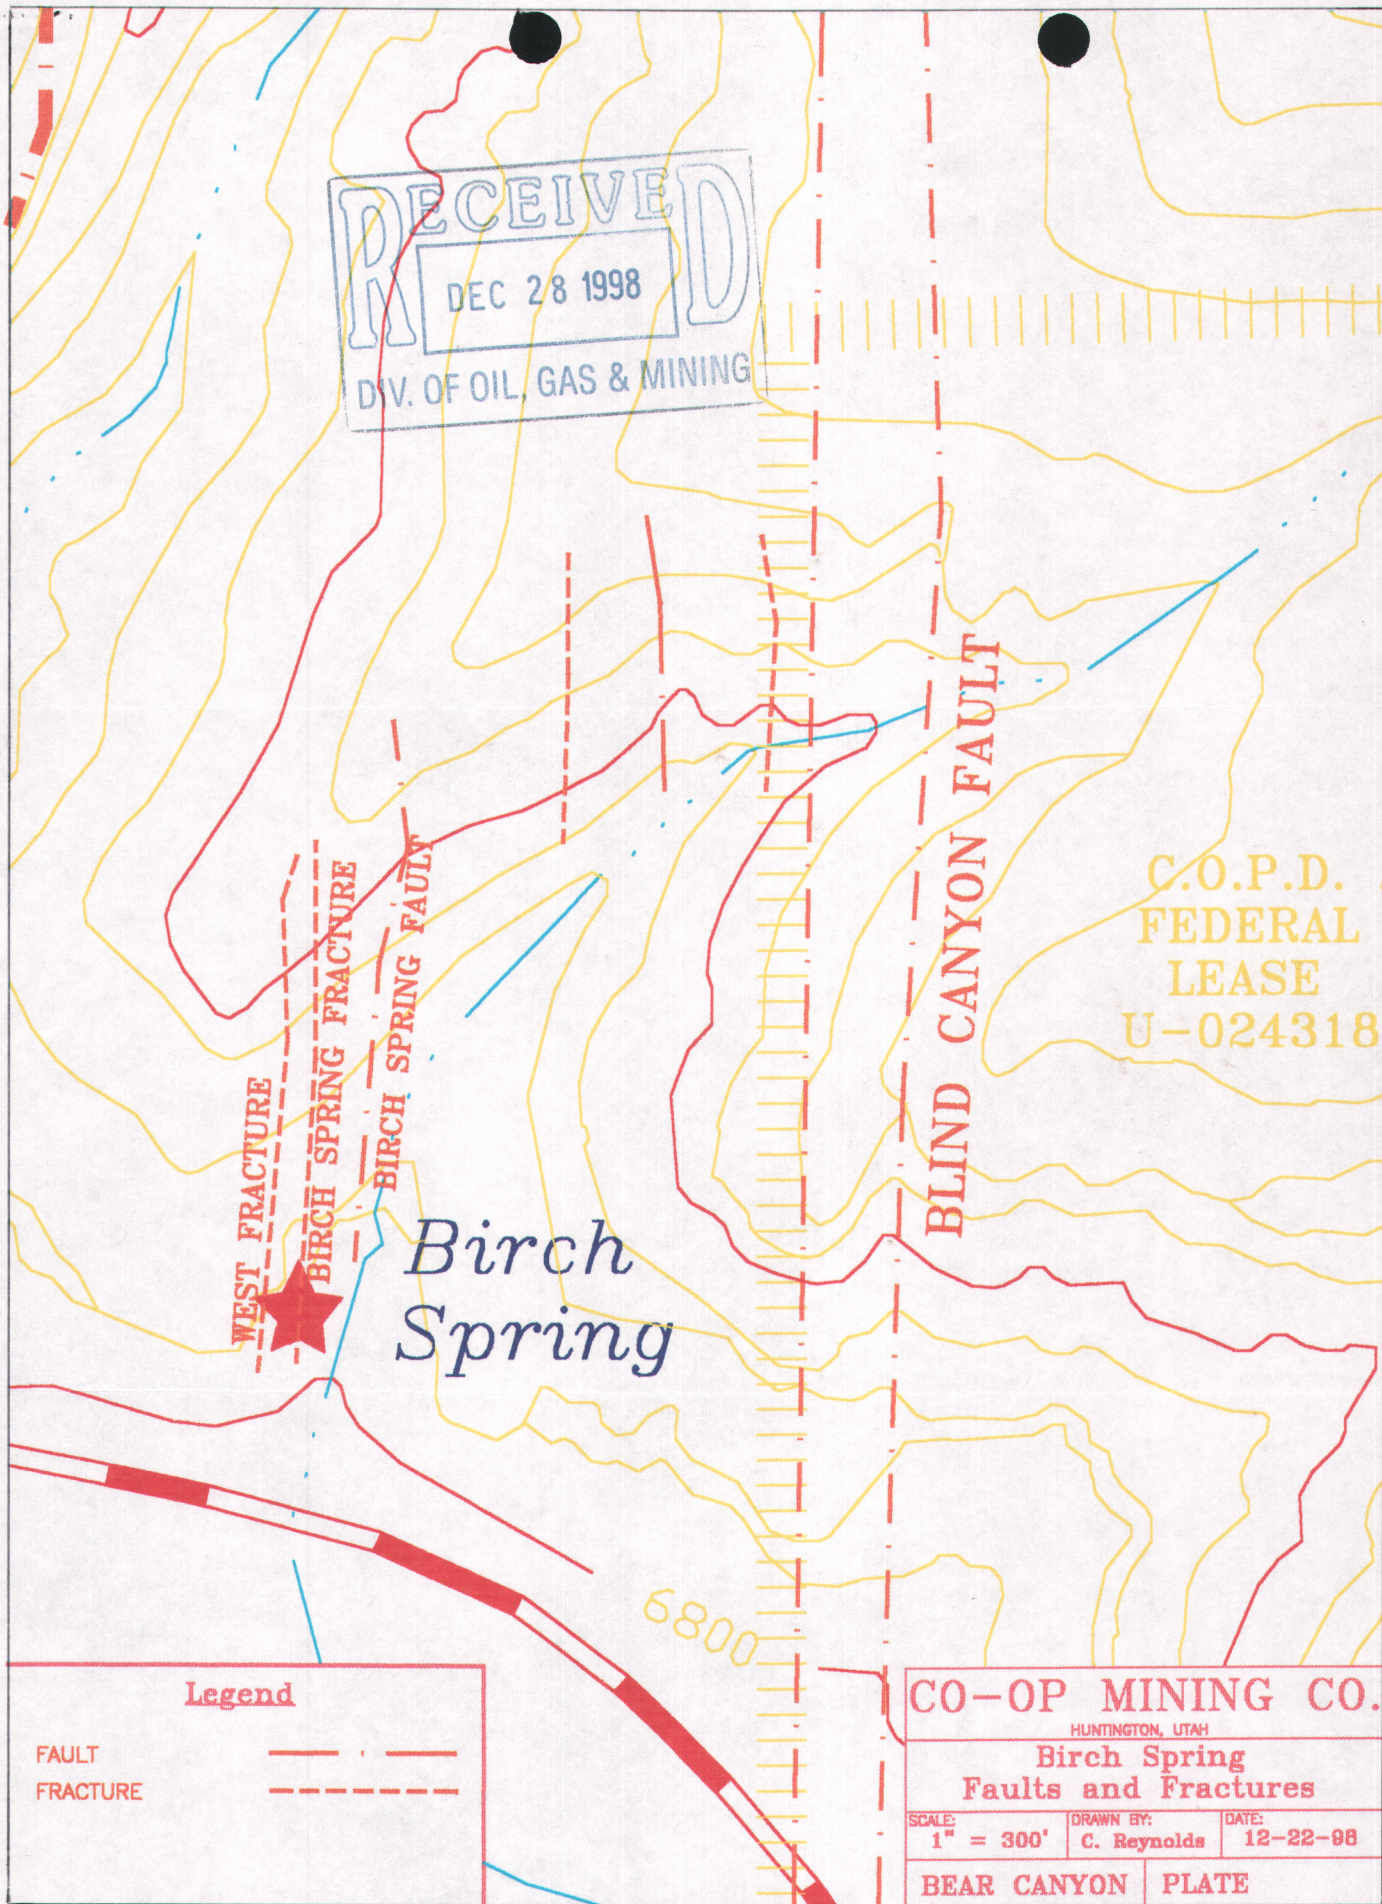
The two fractures and the fault surrounding Birch Spring were mapped Northward to the Ridge between the Birch Spring drainage and Blind Canyon (approximately 1,000 ft). The lack of outcrop prevented following the fractures beyond this point.

1. The joints and faults were consistently aligned North-South $\pm 5^\circ$. One joint of the double fracture was observed in the Spring Canyon tongue striking N 20° W. The fractures appeared to be present in all three tongues of the Starpoint Sandstone, indicating good continuity vertically, but with few exceptions were not prominently observable within the shale layers as they were within the sandstone formations.

2. The spacing between the faults and fractures showed limited variation, but appeared to be steadily converging Northward and/or upward. Due to the terrain in the area, no determination could be made on what component of the convergence might be horizontal or vertical. The fractures did not completely converge within the mapped area, and none of the fractures converged with the Blind Canyon fault, but seemed to parallel the fault.

3. All of the joints and faults were nearly vertical and planar, and interconnectivity was not well developed or apparent.

The attached map delineates the fractures which were mapped in relation to the Blind Canyon fault and the Spring. From the mapping, it appeared that the joints and fractures have good continuity and may conduct water horizontally in a North/South direction and vertically. Vertical conductivity, however, could potentially be limited by the shale layers, which appear to heal the fractures within the shale formations. None of the fractures converge with the Blind Canyon fault in the vicinity of Birch Spring, and no apparent flow paths were observed to facilitate East/West movement of water from the Blind Canyon Fault to Birch Spring. The fracture system could allow local recharge from precipitation and snowmelt into Birch Spring, which may be enhanced by surficial fractures and/or restricted by shale layers.
